FPO-1-78(18)

SQUAW MOORING PROJECT
FINAL REPORT
VOLUME 1

**FPO-1-78(18)
SEPTEMBER 1978**

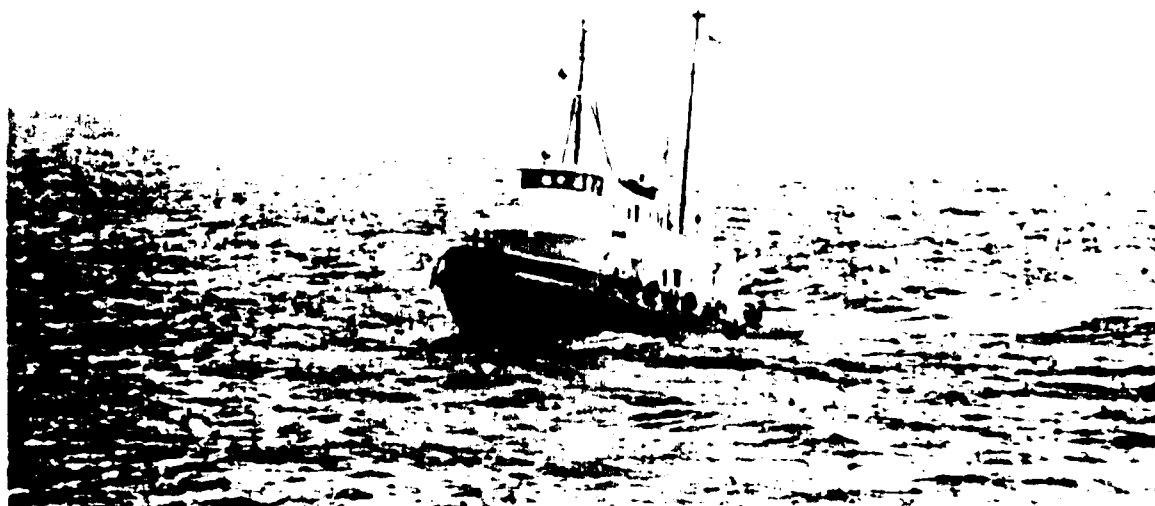
FIGURE 37. THE CONTENDER AT SEA

The depth measuring floats were recovered, and the buoys and lines for electronics package lowering were recovered and hauled back aboard the *MANATI*. An attempt was made to blow the ballast tanks before leaving, but the air hose on board the *MANATI* could not reach the *CONTENDER*. A careful measurement was made of the freeboard at the bow, and the waterline at the after end of the ballast tanks was estimated both from aboard the *MANATI* and aboard the *CONTENDER*. The mean draft was 20.26 feet, well short of the 22.00 feet needed to submerge the ballast tanks.

On the return trip to San Diego, a calculation was made of the additional weight that would be required to sink the *CONTENDER* based upon the final draft measurements, with the conclusion that the *CONTENDER* would need 27.49 tons to sink her. The vertical leg clump weight was 12.45 tons each, and the total weight of each leg was 21.47 tons. The indication was that both vertical leg clumps were missing and probably some fittings and wire were lost as well. Since the moor was quite loose there was probably a part of the two mooring lines as well as all of the 360 feet of mooring chain lying on the bottom. This information was passed on to Crowley when the *MANATI* arrived in San Diego. Meanwhile, the *CONTENDER* remained at sea attending the still surfaced *MANATI*, Figure 37.

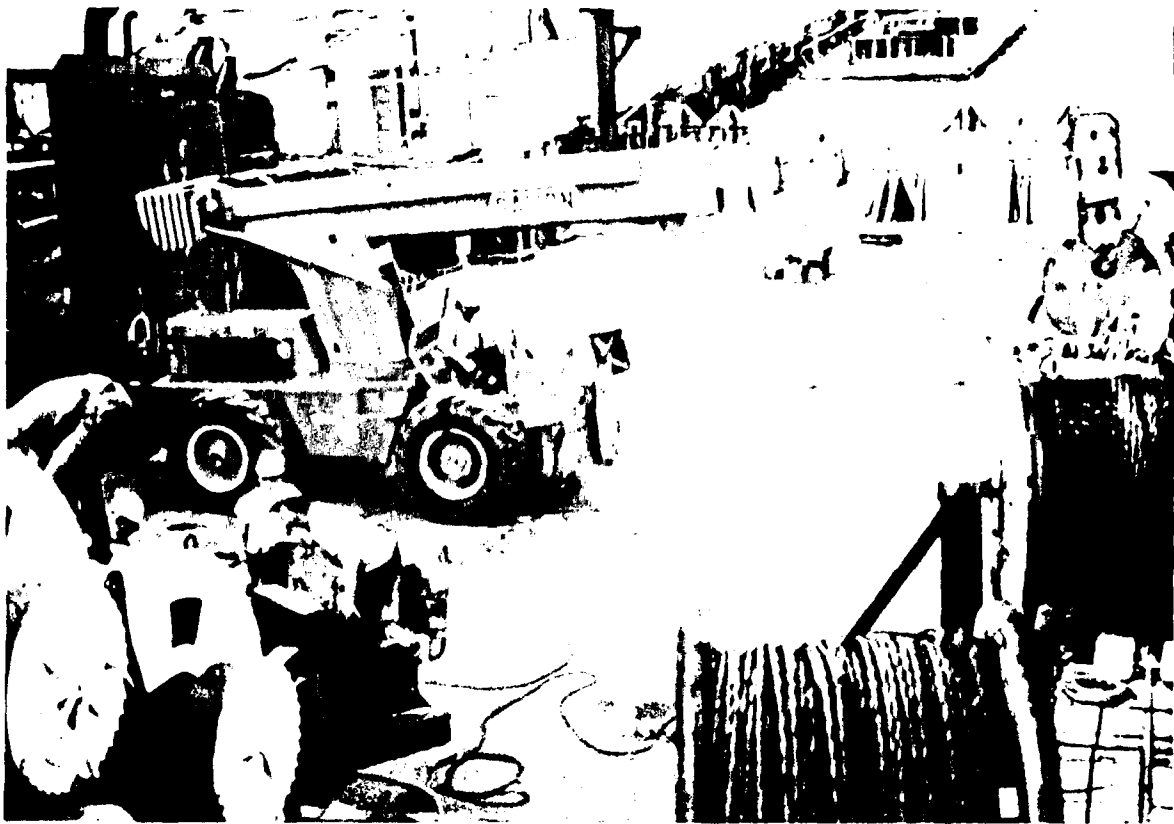
FIGURE 38. TENSIONING AND LEVEL WINDING SYSTEM

For handling weights of any significant magnitude, the wire should be level wound on the winch drum under heavy tension. The provision for this heavy tension level winding is shown in Figure 38. Essentially, the wire was fed off the cable reel and around a horizontal sheave welded to the deck near the stern on the centerline. From there the wire passed through a pair of wooden blocks that were bolted to a frame welded to the deck; the bolts could be tightened to increase the friction loading on the wire passing between the blocks. Leading from the fixed tensioning blocks, the wire passed through a similar pair of blocks that were affixed to the bumper of a mobile crane, passing from there to the winch drum. As the wire was wound on to the drum, the crane would be driven back and forth across the deck in an attempt to achieve a tightly wrapped level wind.

Many deficiencies of this tensioning-level wind system existed. It was inadequate as far as tensioning was concerned and any cable wrapped in this manner could not be used to lower a load of any significant magnitude. Furthermore, to achieve any reasonable tightness of the wrap in an axial direction, the mobile crane had to be jockeyed back and forth and sledges were used to drive the wraps together on the winch drum. This process was extremely slow and inefficient.

One way that a wire could be wound on a winch drum under a workable tension was first to wind it on to the reel as described above, then use it to lower a medium sized clump overboard, unwinding the entire drum. Then the drum would be respooled under the combined tension of the clump and cable weight, using the mobile crane to get a level wind. Figure 39 shows that a tight level wound spooling job could be done in this manner but the time consumed in doing so was disproportionate to the results obtained. An alternative tensioning means was to connect the wire to another of the vessels, reel it out, and then reel it back in under tension while towing the other vessel. This technique was used once successfully but proved equally time consuming.

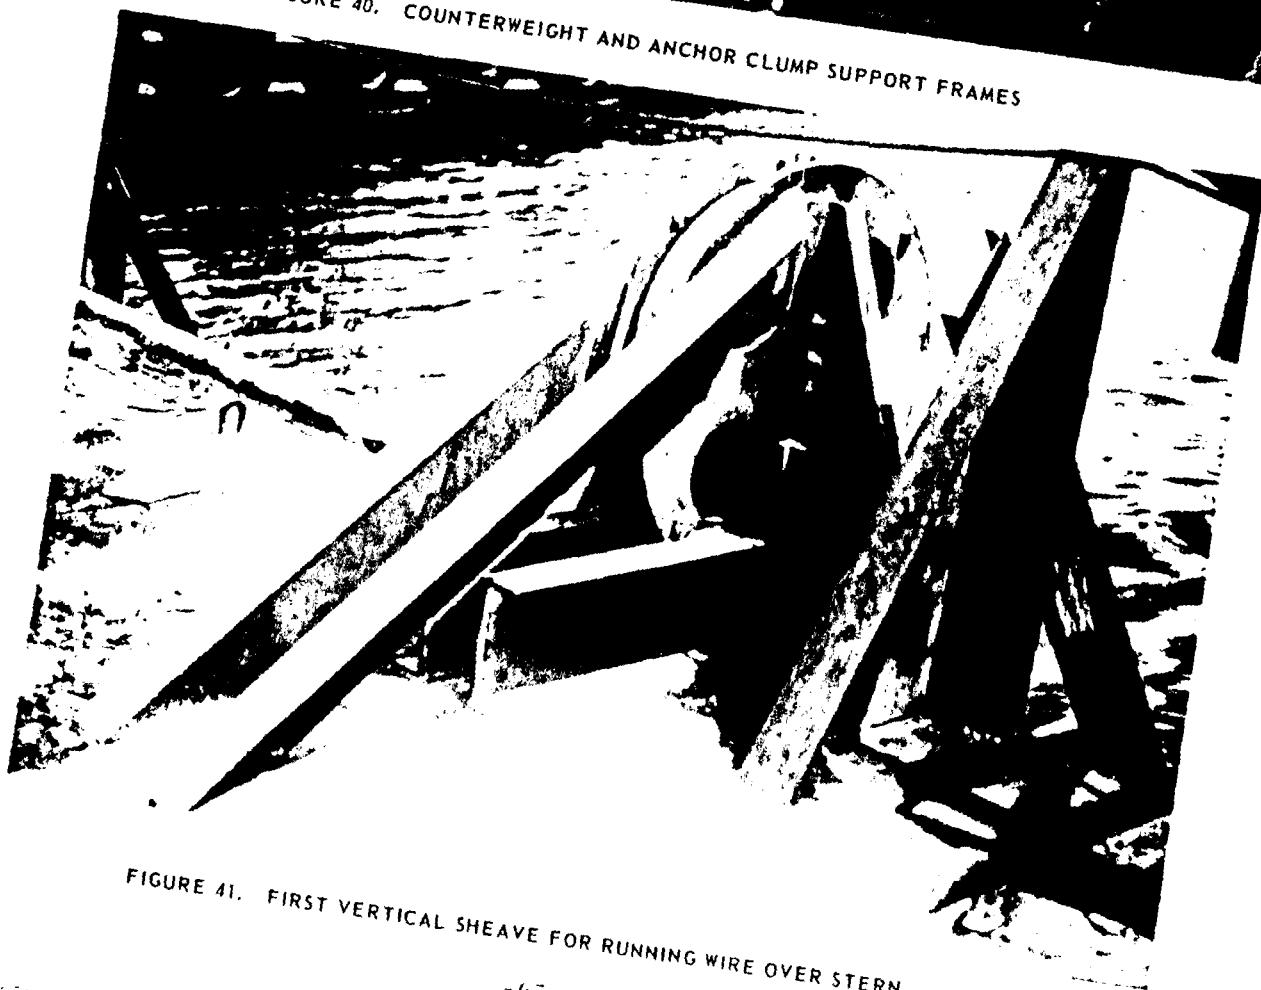
FIGURE 41. FIRST VERTICAL SHEAVE FOR RUNNING WIRE OVER STERN

This did not, however, avoid other cable handling problems that arose. During the paying out of the crown line from the lower winch drum, shown in Figure 39, the bearings failed in the stern sheave which froze in a fixed position. There was no alternative but to pay out the remainder of the crown line, greasing it to slide over the frozen sheave.

The reason for failure of the sheave could not be ascertained on site except that, on disassembly, the bearings appeared to have been pounded to pieces. One interpretation might be that they had been damaged by the cutting in of the wire and subsequent application of severe impact loads to the sheave during the initial lowering of the north anchor. It may be noted that at this point total weight hanging over the sheave was more than 34000 pounds. When this load was dropped one to three feet and brought up short, the impact loading on the sheave bearings was the resultant of the vertical load downward and the horizontal load in the wire running back to the winch drum. A similar load was being applied torsionally to the winch at maximum radius.

The next operational use of the cable handling system under load was on the morning of 3 July 1978, after replacement of the stern sheave in the early morning of 2 July. In order to respool an 8570 foot length of 1 1/4 inch wire on the winch drum under tension, a 6000 pound weight was lowered to the bottom, the remaining 2200 feet of wire payed out, and then the respooling under tension began. This was done in preparation for using that particular wire as a lowering line for the after vertical leg counterweight. The 100 kip acoustic release was also installed in-line.

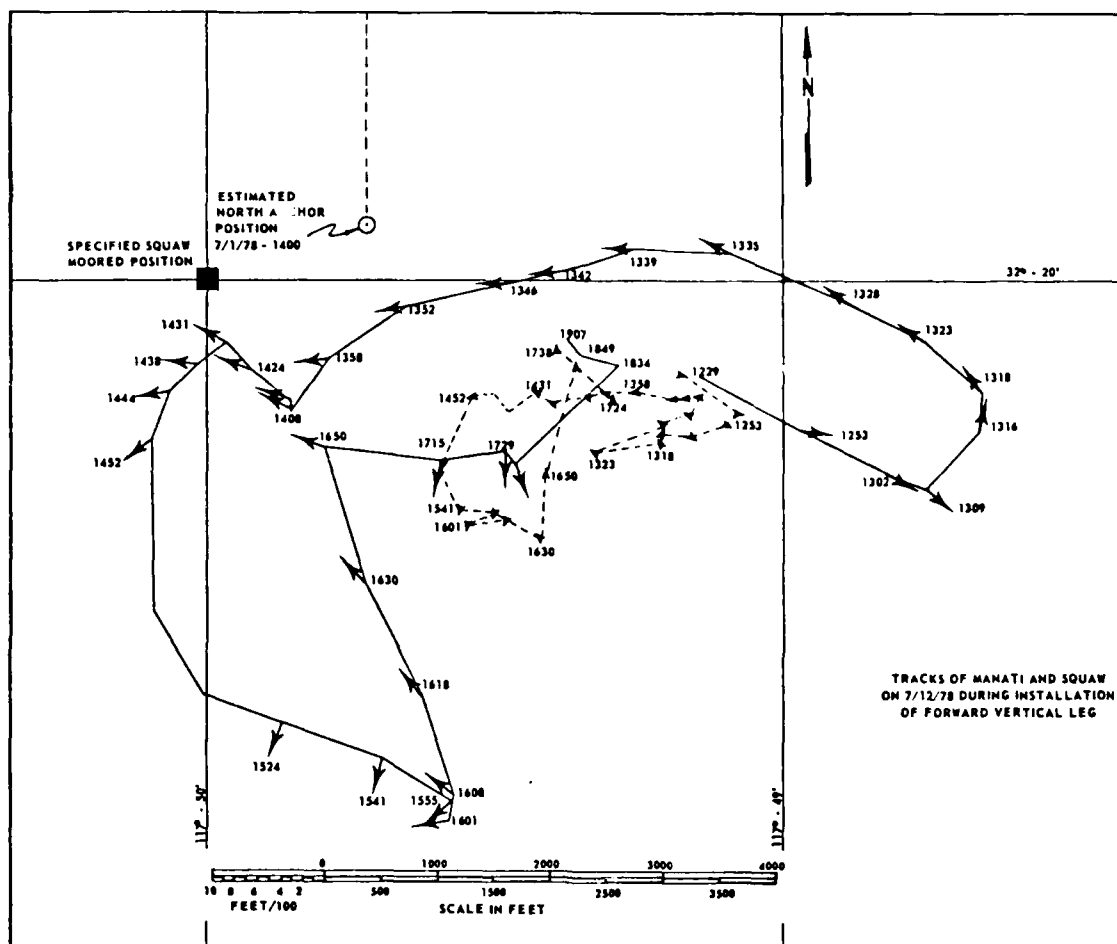
FIGURE 47. TRACKS OF THE MANATI AND SQUAW ON 12 JULY 1978

Just before noon on 12 July 1978, the *MANATI* moved over to the *SQUAW* to shackle up the chain on the forward padeye below the submarine to the chain on the deck of the *MANATI*. At this time the *SQUAW* was headed at 105° true with its stern upsea toward the north anchor about 3000 feet from the estimated anchor position as shown in Figure 47.

Throughout this exercise the *CONTENDER* had been controlling the bow of the *MANATI*. In a somewhat desperate attempt to get around to the port side of the *SQUAW*, at 1444, the *CONTENDER* was ordered to pull first to the south and then to the southeast but, by 1601 the *MANATI* was directly south of the *SQUAW* and the submarine was headed directly toward her, i.e., a heading of 180°.

As described earlier, and as depicted in Figure 47, it is almost certain that, when the forward vertical leg was lowered it was actually wrapped clockwise, looking downward, around the bow mooring line. Furthermore, it is believed that the lowering line, connected to the forward counterweight, then followed a path upward and counterclockwise to the point where it was secured to the after port mooring bitts of the *SQUAW*. Thus, both the vertical leg and its lowering line were wrapped around the bow mooring line. The mooring line generally followed a catenary from the bow chock to its anchor, and since the forward leg was hanging directly down from a point on the bottom 35 feet aft of the bow, thus the chains at the tops of the vertical leg and the mooring line probably crossed a short distance below the hull whereas the crossing of the lowering line and the bow mooring line was probably far below the surface.

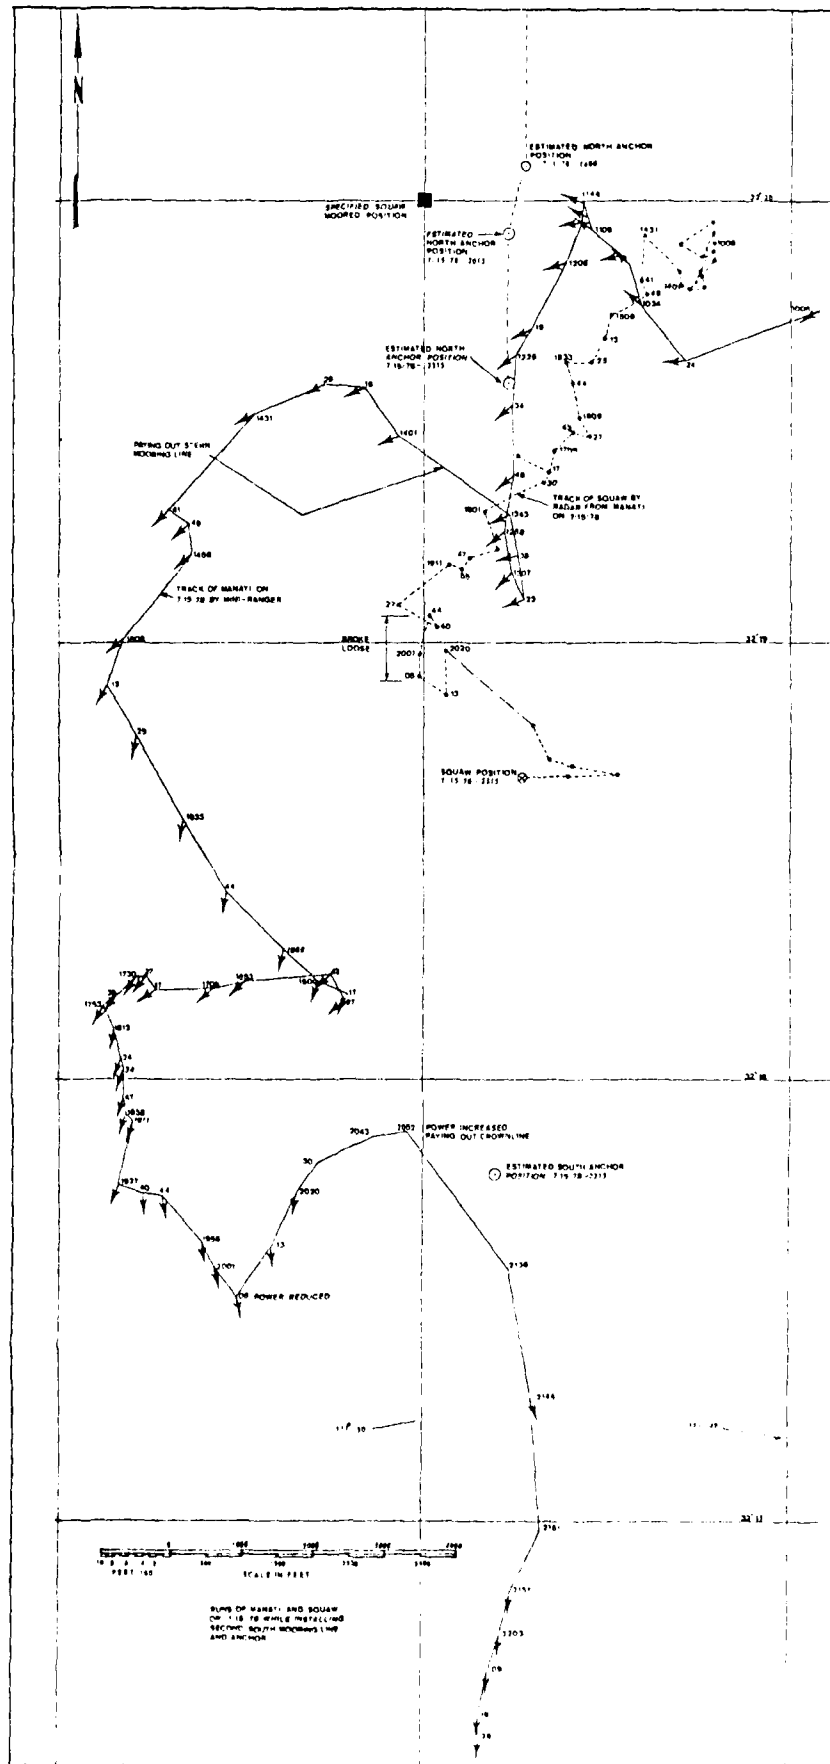
FIGURE 48. TRACKS OF HANATANI AND SQUAW ON 15 JULY 1978

The first part of the operation was a pull intended to make an additional check on the integrity of the bow mooring line. As shown in Figure 48 this basic run was made between 1144 and 1323. During this period the *SQUAW* was close astern of the *MANATI* so its track is not shown. The north mooring line and anchor appeared to be satisfactory so the *MANATI* then began paying out the new stern mooring line as it moved back toward the north anchor. By the time the 8700 feet of mooring line and 180 feet of chain had been payed out, the *MANATI* was 4500 feet to the southwest of the *SQUAW*, and the submarine had been drawn back to its earlier position, 2700 feet east southeast of the estimated north anchor position.

The maneuver to bring the *SQUAW* to its target moored position and to drop the new south anchor on its target began at 1401. Although the *MANATI* was headed to the southwest it actually moved initially to the northwest and, as can be seen in Figure 48 the *SQUAW*, still heading southeast, moved northwest toward the anchor position. This gave a fairly good indication of where the anchor was at this point.

At this point, the *ZODIAC* returned to the *SQUAW* and it was found that she had assumed a north-south orientation, that underwater noises at the bow mooring line connection had ceased, and that there was now about a 15° lead angle with the vertical of the bow mooring chain. As will be discussed in Part VI, this was a probable point of a major failure in the system.

At 2144 the run south was initiated when sufficient crown line had been payed out. At 2228 power was cut and the anchor dropped to the bottom. The drop was slightly delayed and so it appeared that the north anchor had been dragged another 2000 feet south. The estimated positions of the north and south anchors and of the moored *SQUAW* are shown in Figure 48. This completed the new south mooring implantment operations.

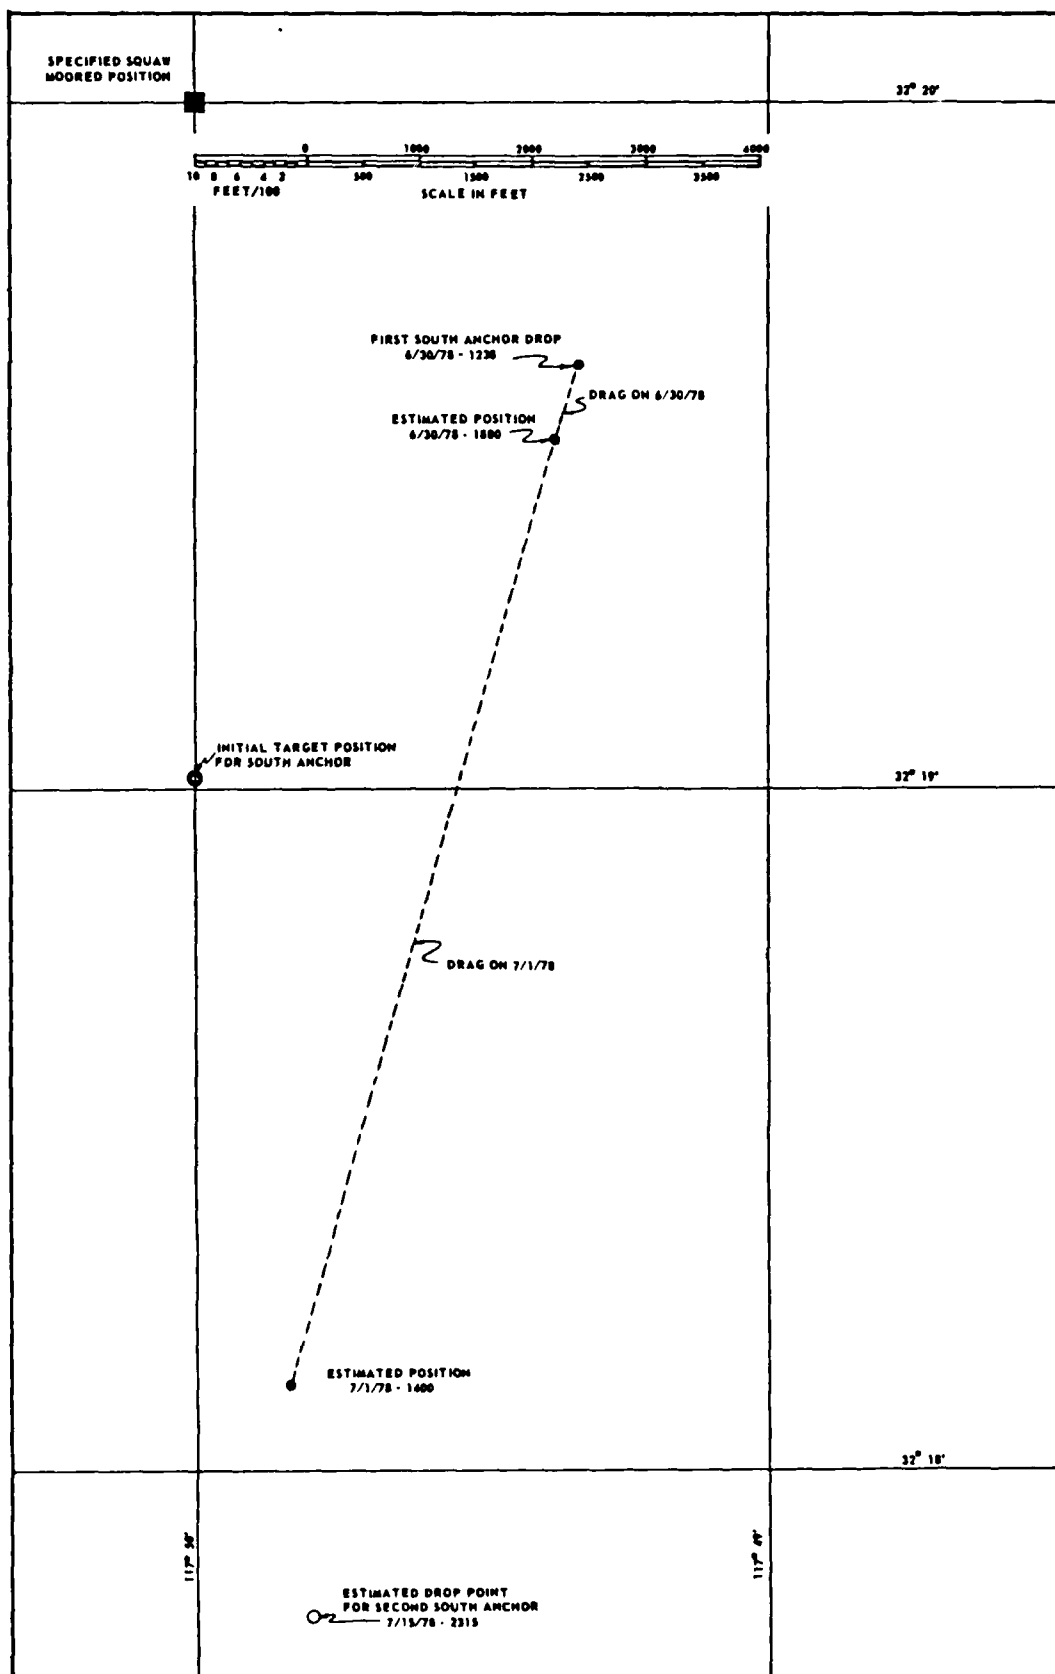
FIGURE 50. POSITIONS OF THE TWO SOUTH ANCHORS

The position of the first and second south anchors, on the other hand, while not known as precisely originally were subjected to far less movement. Therefore, the positions shown in Figure 50 are probably reasonably accurate.

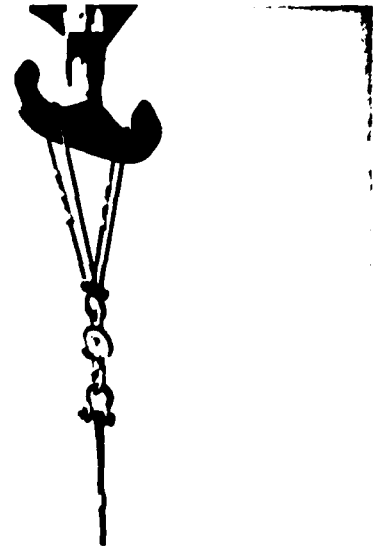
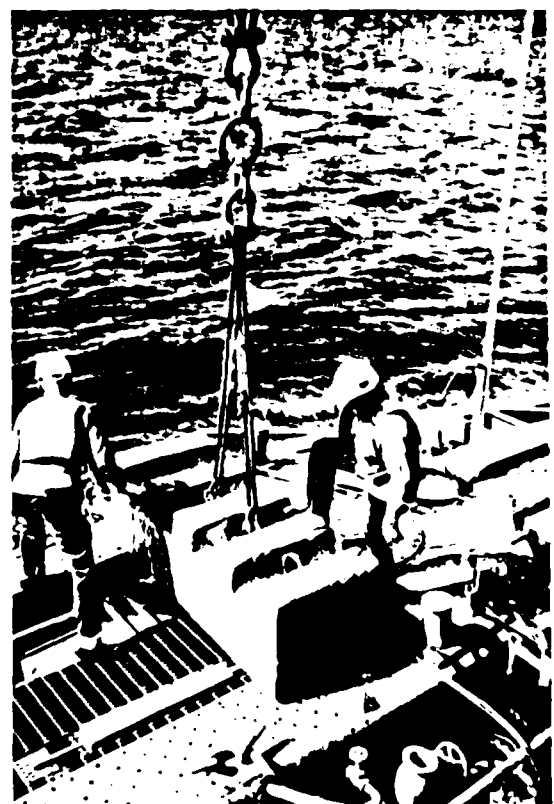
FIGURE 57

A calibrated 50000 pound dynamometer was hung from the crane hook and read as each weight was handled. As a back-up, the tension read-out system on the crane barge was checked each time a dynamometer was read. In each case the two readings were identical, or no more than 200 pounds different. Photographs of these operations are shown in Figure 57.

As demonstrated in the copy below of the test certification, the total weight required to submerge the *SQUAW* was 107000 pounds. The minimal difference

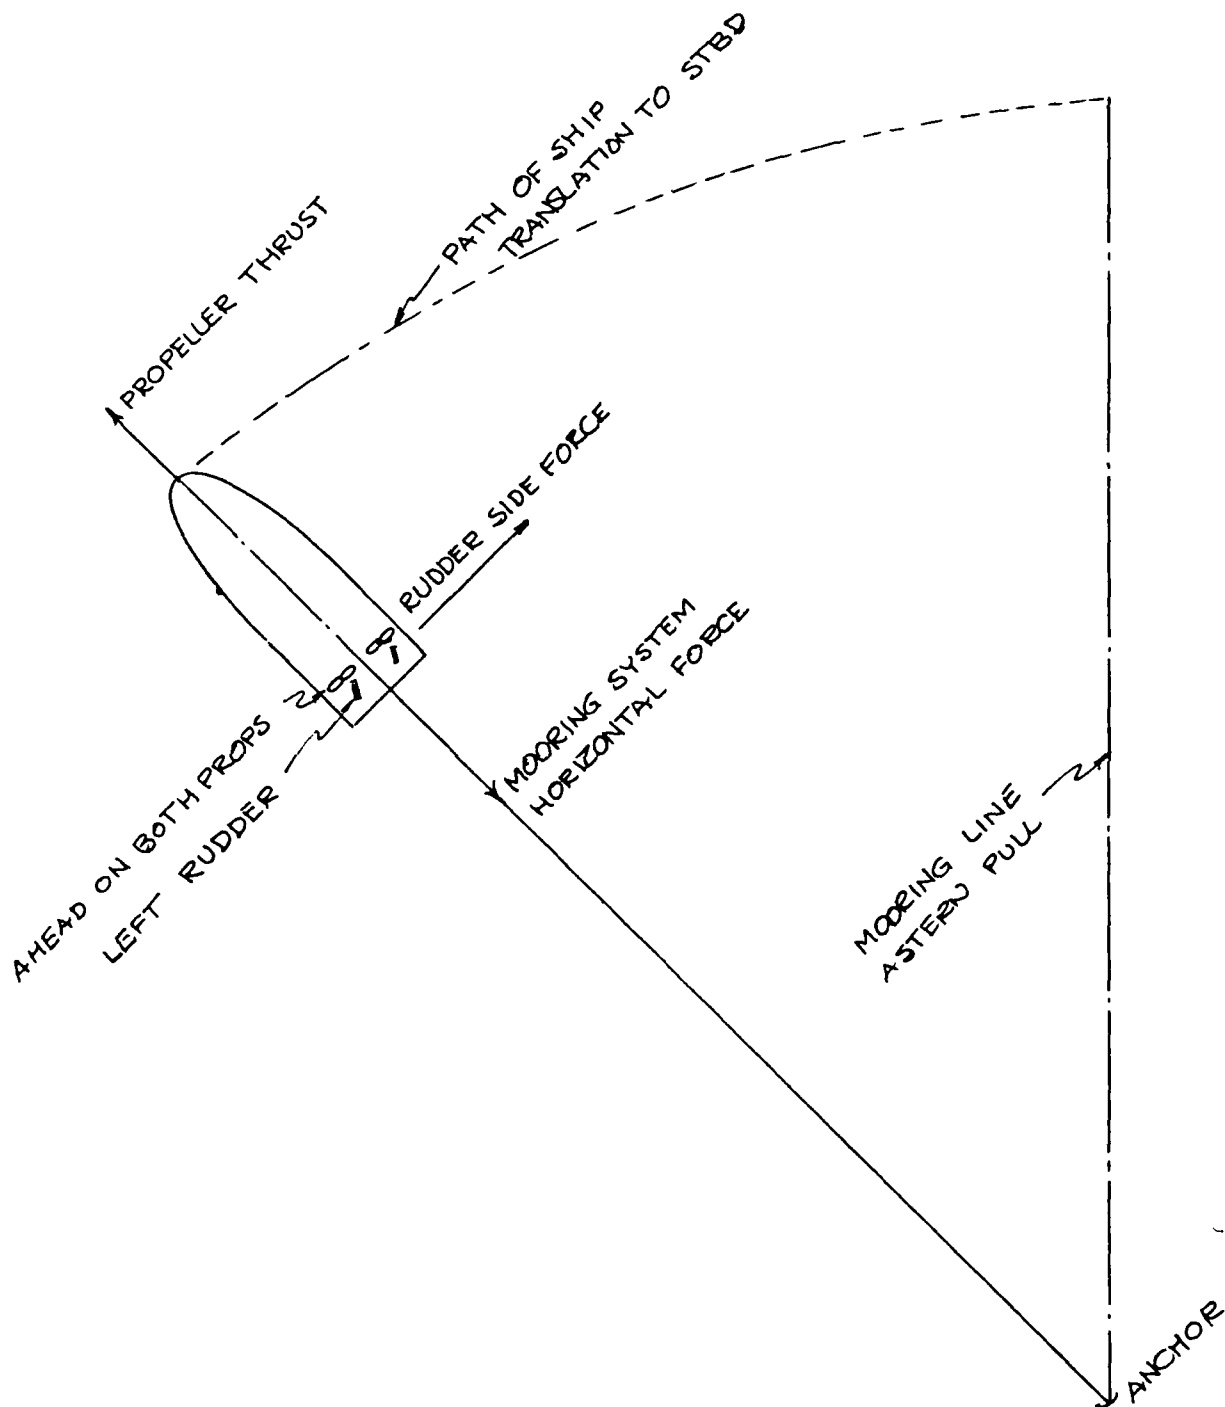
The control of maneuvers when the MANATI was connected to the bottom through the SQUAW mooring system left something to be desired. The tug CHALLENGER was called upon to tow the MANATI on several occasions when it was really not necessary. Furthermore, the resulting movements of the system were not well controlled resulting in anchor movements to unplanned locations. When attempting to pull out an anchor line catenary the tendency was to try to rotate the MANATI to a desired heading by using the engines - one prop ahead and the other reversed. This applies a minimal torque to the hull which is opposed by the athwartships component of the mooring line pull times the distance between the propellers and the point of attachment of the mooring lines. The mooring line force wins every time. Actually the way such an operation should be conducted is to run the two screws of the MANATI ahead to apply an ahead thrust and to swing the rudders to apply a side force acting in the direction of desired movement. This rudder motion is the opposite of what would be used to head the MANATI toward the target. This is illustrated in the following diagram of a typical moor towing situation.
